# **OPERATING EXPERIENCE WEEKLY SUMMARY**

**Office of Nuclear and Facility Safety**

**January 29 - February 4 , 1999**

**Summary 99-05**

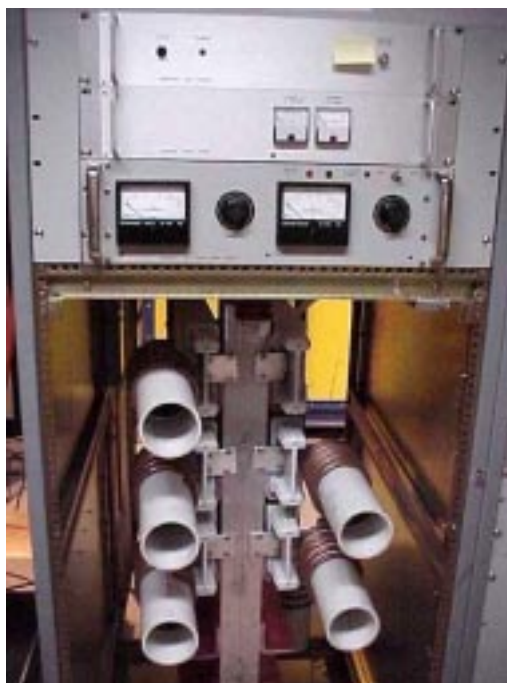
**Figure 2-1. Undamaged Modulator Cabinet**

Investigators determined that the operators had used Halon and dry chemical fire extinguishers to try to put out the fire, which was suppressed and flared up again after each extinguisher was discharged. Investigators believe that a low-voltage cooling fan installed on top of the modulator was exhausting the Halon from inside the modulator, thereby preventing the fire from being fully extinguished. They determined that when the operators shut off the high-voltage disconnect switch it did not de-energize the fan. Investigators also determined that when fire and rescue personnel opened the modulator door they noticed that control lights on the cabinet were lit. Plant engineering electrical staff personnel turned off the breakers to all of the modulators to ensure that no equipment remained energized. Investigators determined that the operators had not shut off the low voltage to the modulator nor were they aware how to secure the low voltage. They determined further that because all three of the operators on shift were attempting to extinguish the fire, the control room was unmanned and the NSLS remained running. After the fire, the operators re-entered the facility, accessed the control room, and shut down the NSLS. Investigators determined that the operators did not completely follow the facility emergency procedure for a fire. Figure 2-1 shows an undamaged modulator cabinet. Figure 2-2 shows the modulator cabinet after the fire.

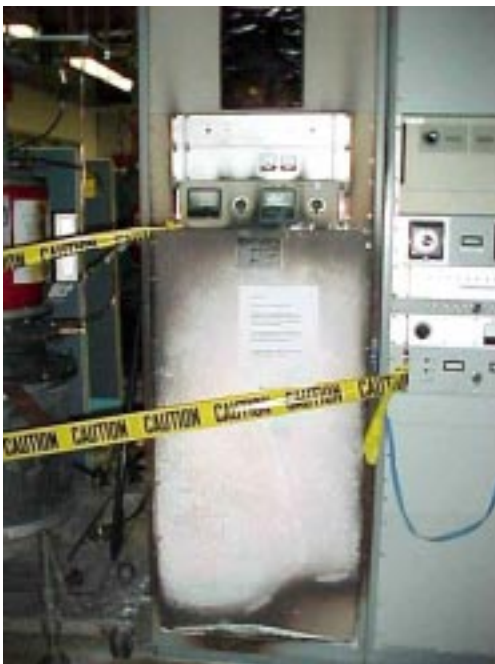
**Figure 2-2. Fire-Damaged Modulator Cabinet**

Investigators determined that the capacitors were oil-filled (non-PCB), had polyethylene cases, were supported by fiberglass racks, and used timing tuning coils wrapped around polyvinyl chloride piping, resulting in approximately 10 pounds of plastic inside the modulator. The burning plastic caused dense smoke during the fire. Facility personnel have completed modulator repairs and testing of a newly installed modulator. The NSLS has restarted. The facility chairman appointed an investigation committee to review the event. In addition, the following interim actions have been performed.

- Workers installed quick shutoff switches that de-energize the high- and low-voltage power to the modulator as well as the cooling fan. They installed these at all three modulators and in the control room.
- Facility personnel modified operations so as to energize the modulator only when it is required for National Synchrotron Light Source operation (approximately 1 hour a day during the injection phase) instead of continuously.
- An operator is required to be on standby in the area whenever the modulator is operating and to be in possession of emergency instructions and a Halon fire extinguisher.

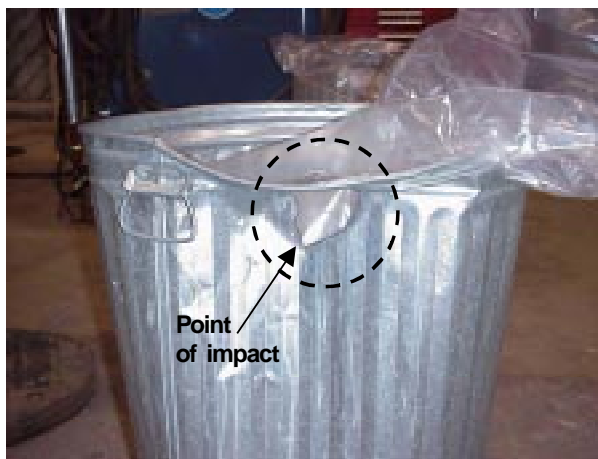
**Figure 3-1. Damaged Garbage Can**

On January 26, 1999, at the Hanford Site, a pipe fitter was grinding slag from the flame-cut edge of a 3/8-inch thick metal plate when the grinding wheel, a 6-inch-diameter cup stone, disintegrated. The guard of the hand-held pneumatic grinder protected the pipe fitter and deflected the broken pieces away and down toward the floor. The largest segment traveled approximately 15 feet and struck a metal garbage can, penetrating one side of the can and propelling it approximately 15 feet. Other fragments were distributed over an area with approximately a 12-foot radius. There were no injuries, and property damage was limited to the grinding wheel and the garbage can. (ORPS Report RL--PHMC-FSS-1999-0006)

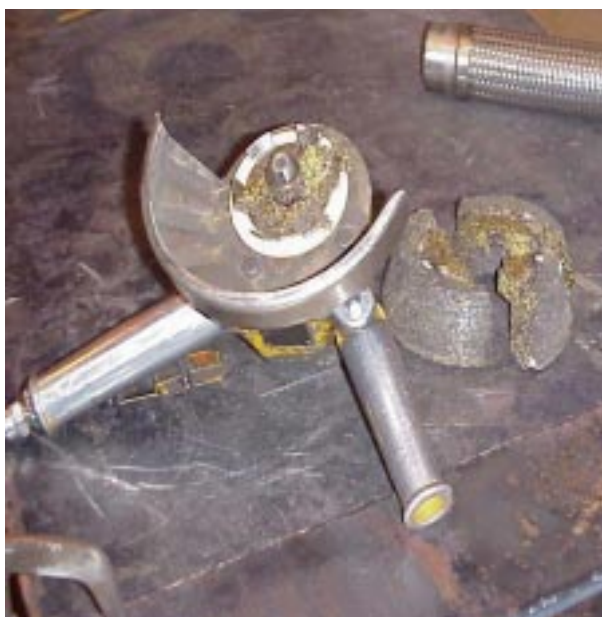
**Figure 3-2. Grinder and Pieces of Cup Stone**

The pipe fitter stopped work and notified his immediate supervisor. The facility manager immediately ordered shop personnel to halt all grinding operations pending completion of an inspection of all grinding wheels in the facility for visible damage and verification that no wheels were mounted in grinders having rated speeds greater than the allowable wheel speed. The only grinder capable of exceeding the rated maximum speed of any grinding wheel in the facility was the grinder associated with this event, and the facility manager ordered that it be removed from service. Figure 3-1 shows the damaged garbage can. Figure 3-2 shows the grinder and pieces of the cup stone.

Investigators determined that the pipe fitter was wearing safety glasses with side shields, a full-face grinding shield, ear protection, leather gloves, safety-toed shoes, and long-sleeved coveralls. A protective grinding/ultraviolet flash shield was in place between the grinding operation and nearby employees. Investigators also determined that the pipe fitter had performed a pre-use visual inspection of the cup stone and grinder and did not observe any chipped areas, cracks, or other damage. They also determined that the cup stone label indicating rated speed and stone composition was not legible. They later determined that the cup stone was rated for up to 6,000 rpm and that the grinder was rated for 7,700 rpm. Investigators have not yet determined (1) how this wheel came to be mounted on this grinder, (2) what the facility requirements are for testing and inspecting grinding wheels, or (3) when the disintegrated wheel was last tested. Investigators are

trying to fully determine the cause of the grinding wheel failure and the appropriate corrective actions.

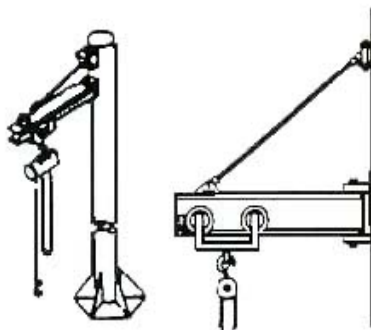
**Figure 5-1. Jib Cranes**

The production technicians in the bay immediately stopped using the chain hoist, which can also be referred to as a jib crane, and contacted the operations manager, the assistant facility manager, and the DOE facility representative. The hoist trolley is mounted on a rail of the jib approximately 12 to 15 feet above the floor. The jib is attached to a wall and can be positioned through an arc by means of a rope attached to its end. The retaining bucket is made of sheet metal and is 8 inches long, 3 inches wide, and 10 inches deep. Production technicians use two ropes to operate the "up" and "down" controls for the hoist. Figure 5-1 shows two examples of jib cranes.

The facility manager conducted a critique of the event on January 26 and determined that the operator was moving the chain hoist away from the workstation when the load chain fell outside the chain bucket. Crafts personnel and facility personnel believe that the positioning of the anchor point for the load chain may also have contributed to the event because it allowed the chain no slack. When the hoist hook was raised, the load chain started into the bucket but became misaligned, spilling over the side of the bucket. As an interim action, personnel positioned the anchor point for the load chain at a point that gave approximately 3 feet of chain in the bucket. This length would allow gravity to determine a path for the load chain that would cause it to enter the bucket properly but would still provide sufficient travel for required air hoist operations. Operators were cautioned not to move the hoist trolley or position the jib while raising the load chain because doing so could cause the bucket to tilt as the chain played into the bucket.

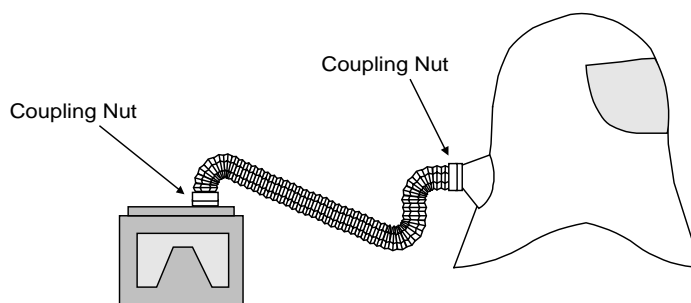
**Figure 7-1.** MSA OptimAir 6 PAPR

Investigators determined that all of the nuts fractured horizontally and that all of the failures were associated with MSA OptimAir 6 PAPR (see Figure 7-1). Respiratory protection personnel restricted use of these models and notified the National Institute for Occupational Safety and Health of the coupling nut failures. Respiratory protection personnel will contact manufacturers to determine what other similar respirators are available for use in the event that MSA does not provide an acceptable resolution of this problem. Industrial hygienists will assist workers in selecting the proper respirator to be used in place of the MSA PAPR.
